INDEPENDENT SAROP REVIEW

Essence SAR Operation

Location: 20 nm North of Cape Brett, Northland
34 50.31S 174 25.20E

Date: 14 October 2019

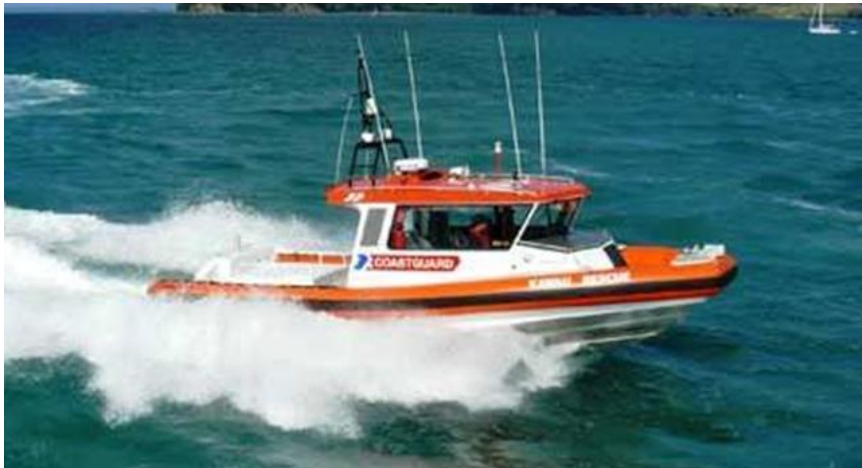
BAY RESCUE II is a 10.2 metre NIAD rigged hull with pontoons and twin jet propulsion units. It is purpose built for Coastguard and surveyed to carry 11 passengers.

Twin sister vessel *KAWAU RESCUE*

- If deploying into such conditions, additional safety equipment needs to be considered, such as helmet headsets to prevent head injuries and enhance the capability to hear radio messaging, harnessing and appropriate seating in the vessels

- During the deployment, items were thrown from their housing including the boats anchor. The floatation rings had to be brought into the cabin, and other equipment was shaken loose from its mounting. Consideration needs to be given to secure storage, especially in heavy sea conditions.
